**BLM Cedar City Field Office  
Site Inspection Report**

To: Case file UTU-72232, 43 CFR 3809 POO  
Gemstone Mining Inc., Red Emerald Mine

From: Ed Ginouves, CCFO Mining Engineer

Subject: Site Inspection

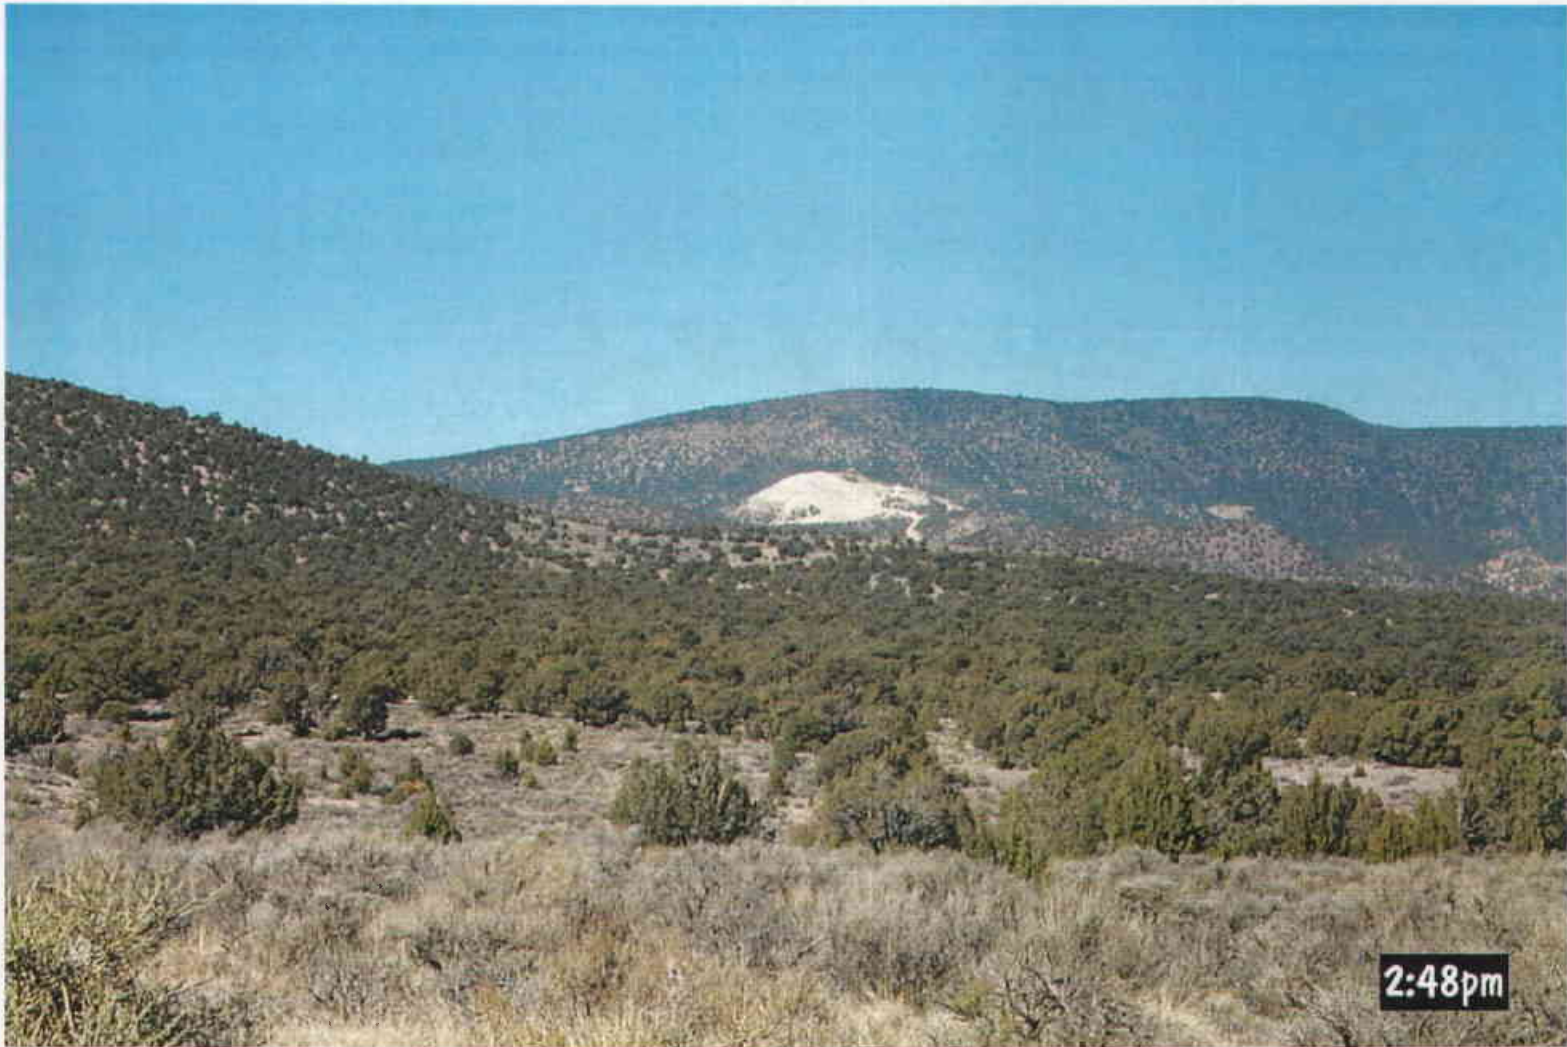
A view of the Red Emerald  
Property from above in the  
fall of 2002. Poor vegetation  
success.
